Debris/Ice/TPS Assessment And Photographic Analysis For Shuttle Mission STS-38

February 1991

DEBRIS/ICE/TPS ASSESSMENT
AND
PHOTOGRAPHIC ANALYSIS
OF
SHUTTLE MISSION STS-38

November 15, 1990

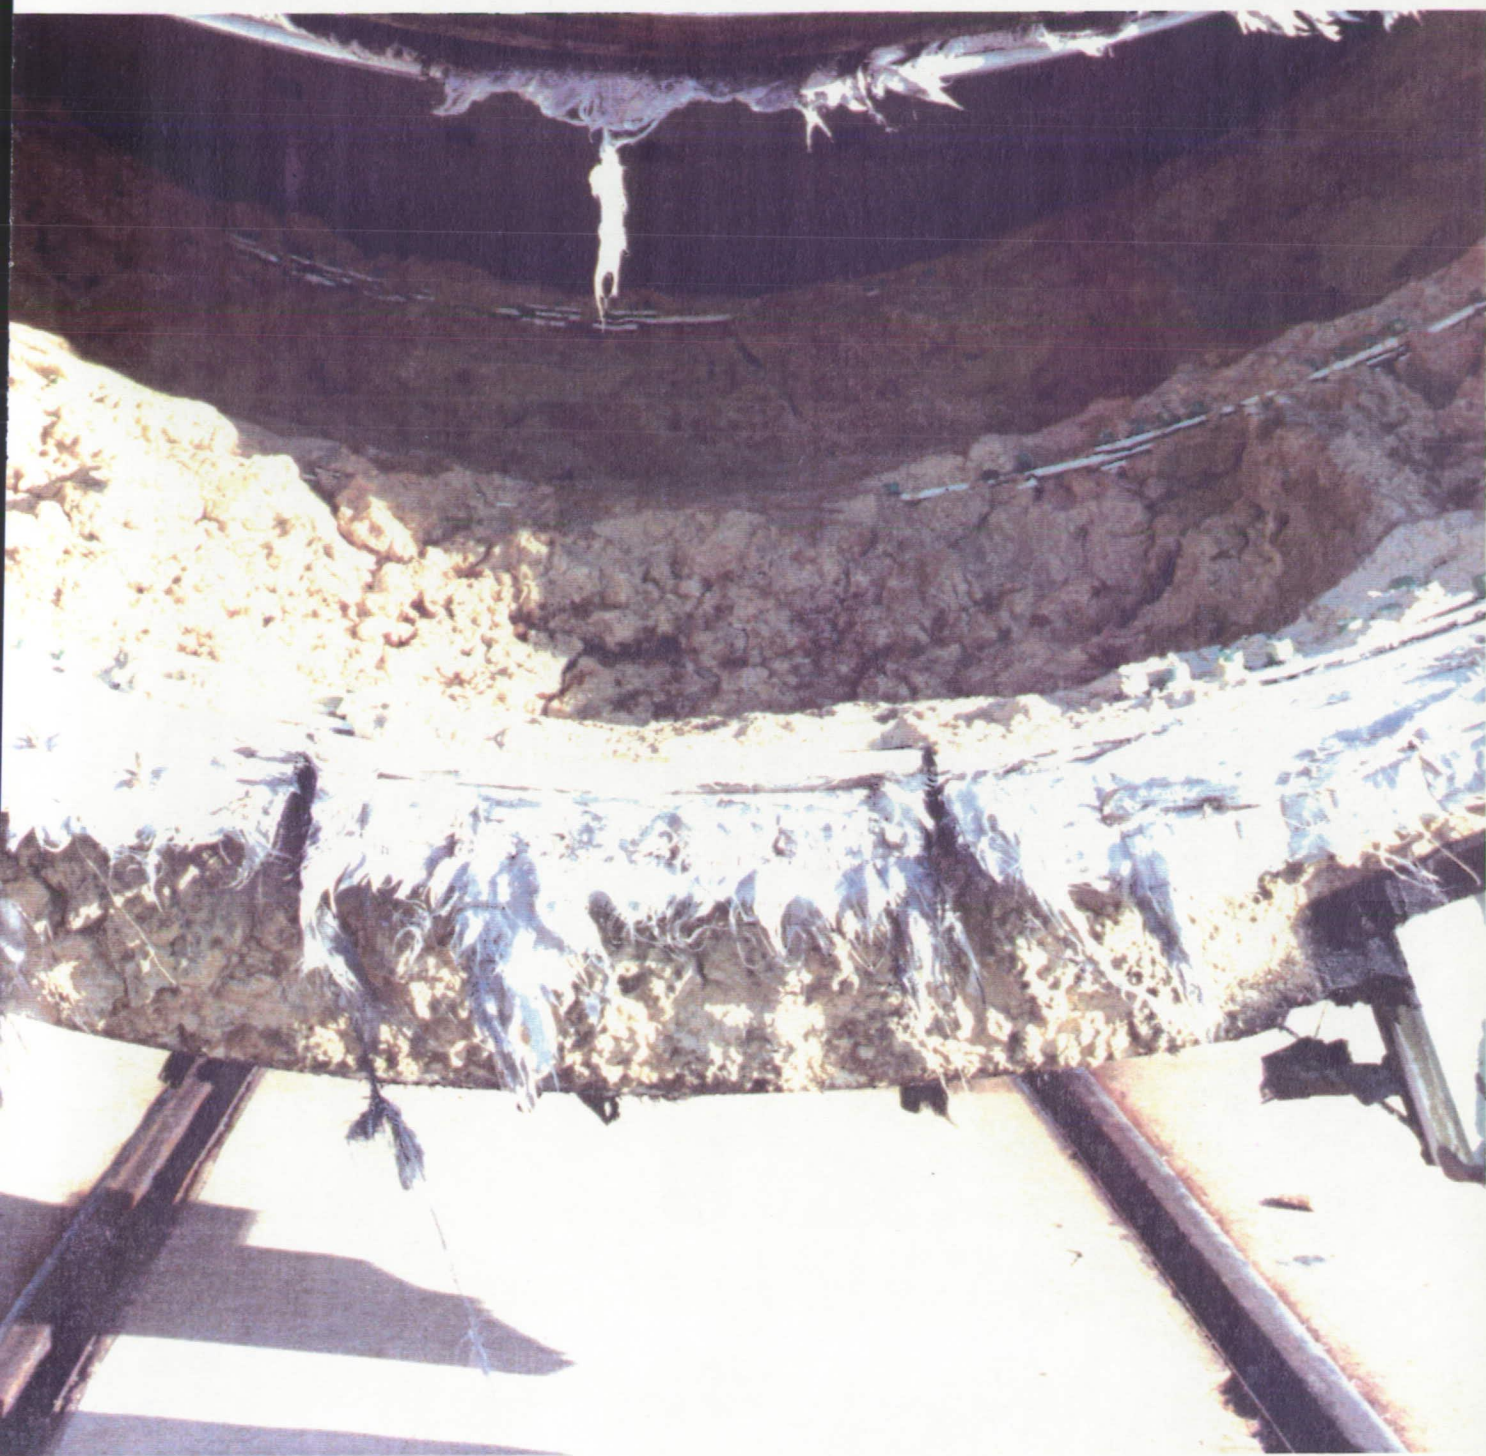
No damage other than typical water impact damage was visible in the -Z area of the LH aft skirt. Analysis of launch films revealed the possible loss of thermal curtain material during ascent at 34 and 39 seconds MET.

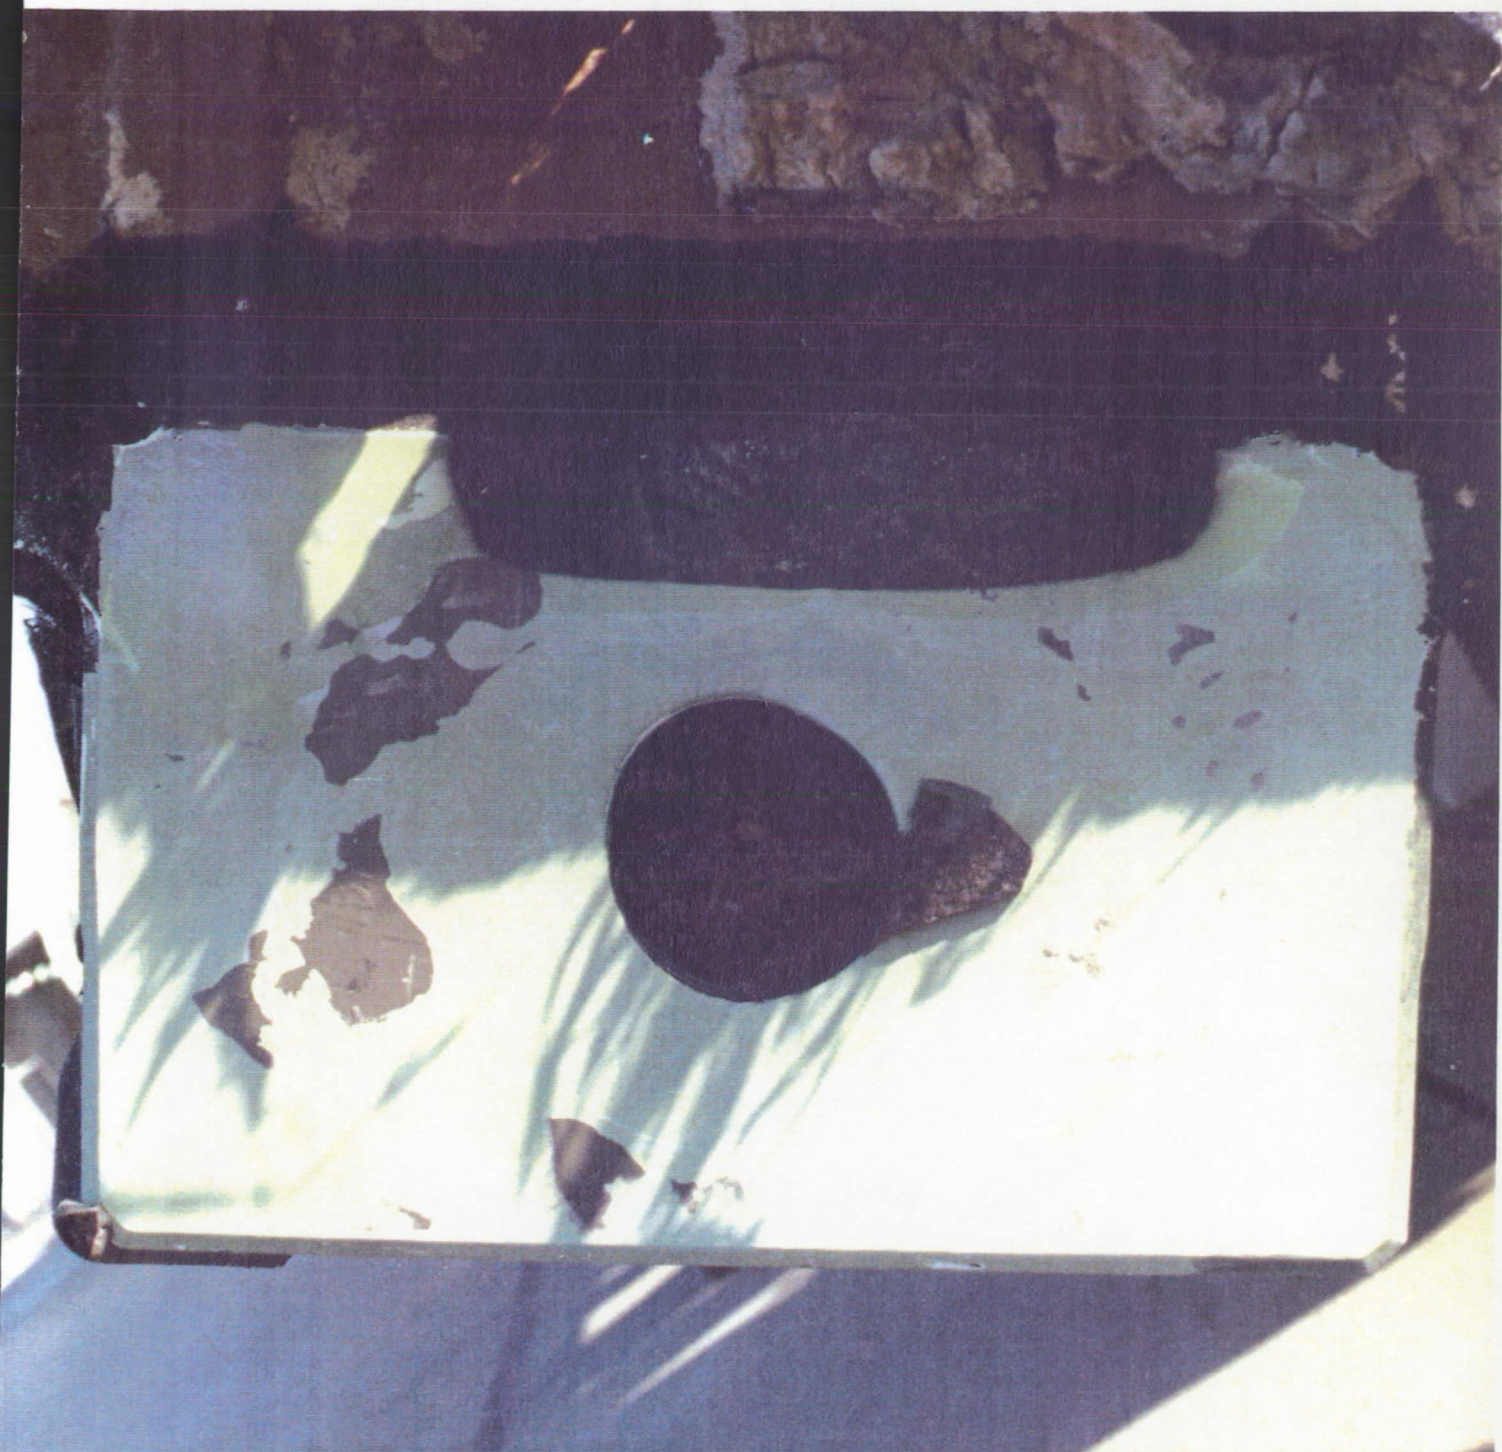
All DCS plungers were properly seated. Aft skirt HDP #7 was missing Epon shim from the inboard side of the foot and the substrate was sooted. A 9"x2" piece of HDP #8 aft face shim material was missing prior to water impact. The thermal curtain attach structure and aft skirt aft ring were inspected for damage caused by the suspected loss of a thermal curtain 34 seconds into flight, but no unusual damage was visible. Water impact may have altered any remaining evidence. Instafoam was missing from the aft ring around the aft skirt feet, HPU exhaust horns, and the SRB T-0 umbilical.

A 9" x 2" piece of HDP #8 aft face EPON shim material was
missing prior to water impact

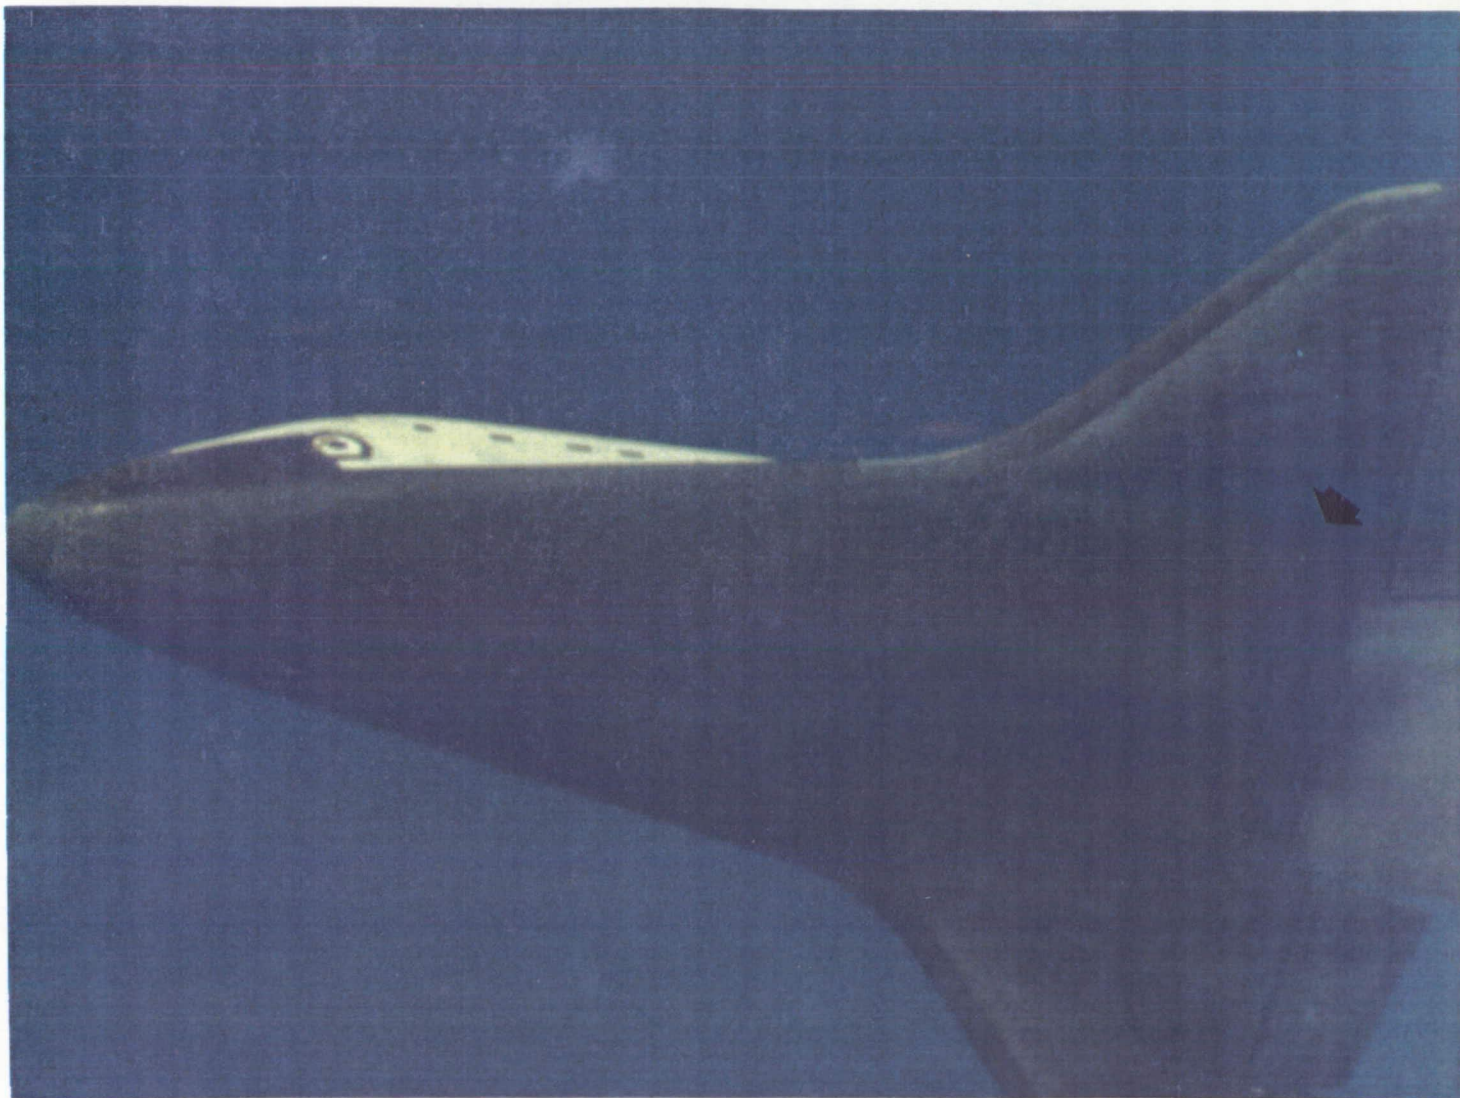
Overall view of lower surface tiles as Orbiter passes over the
camera position. Note tile damage just visible near the ET/ORB
LH2 umbilical area

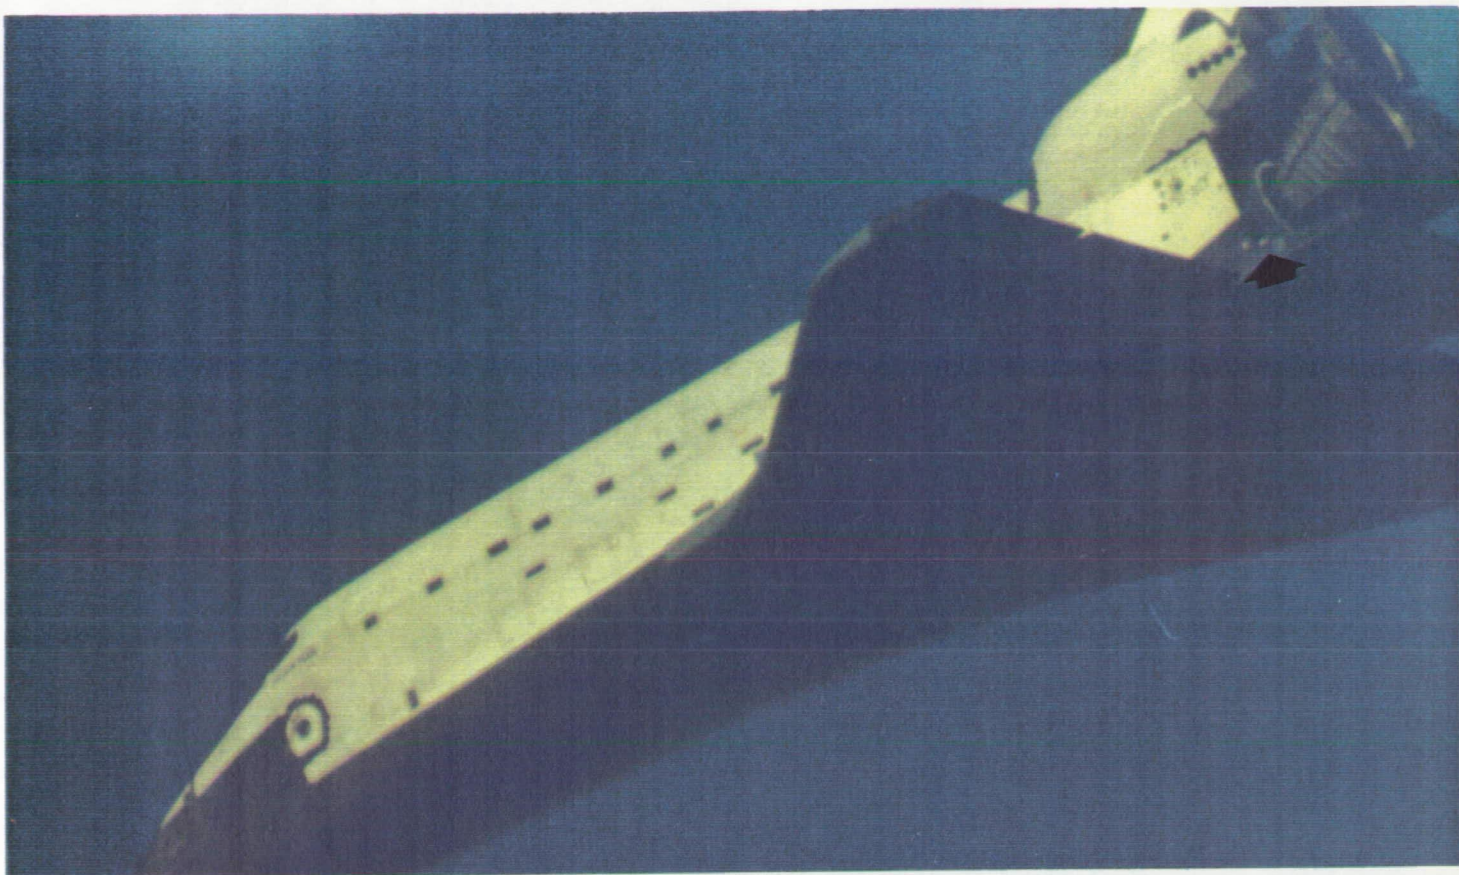
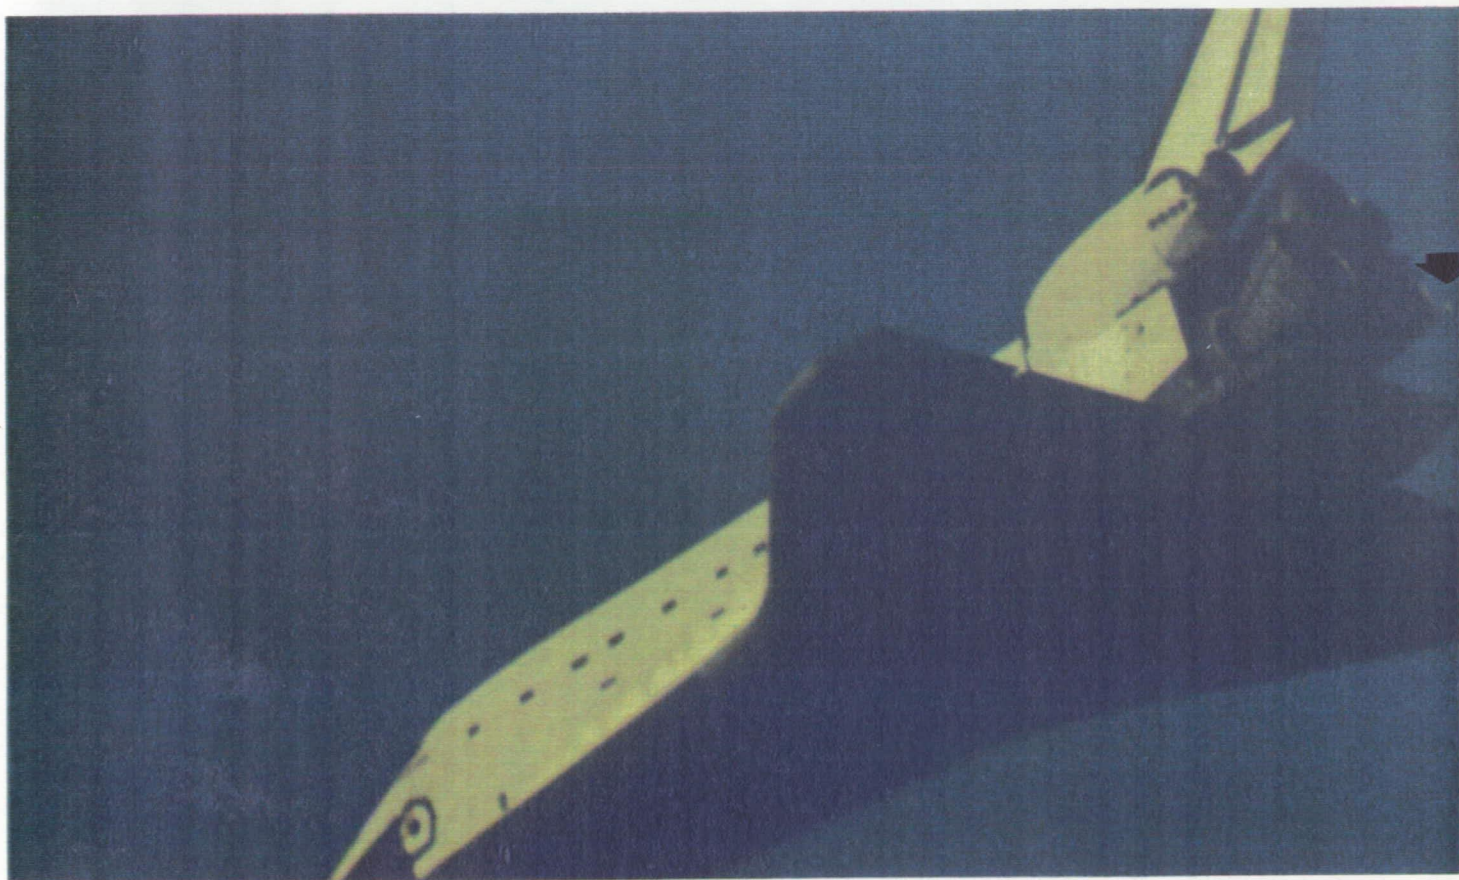
Two pieces of SSME closeout blanket, above the body flap near
SSME #2 and outboard of SSME #3, fell aft during final approach

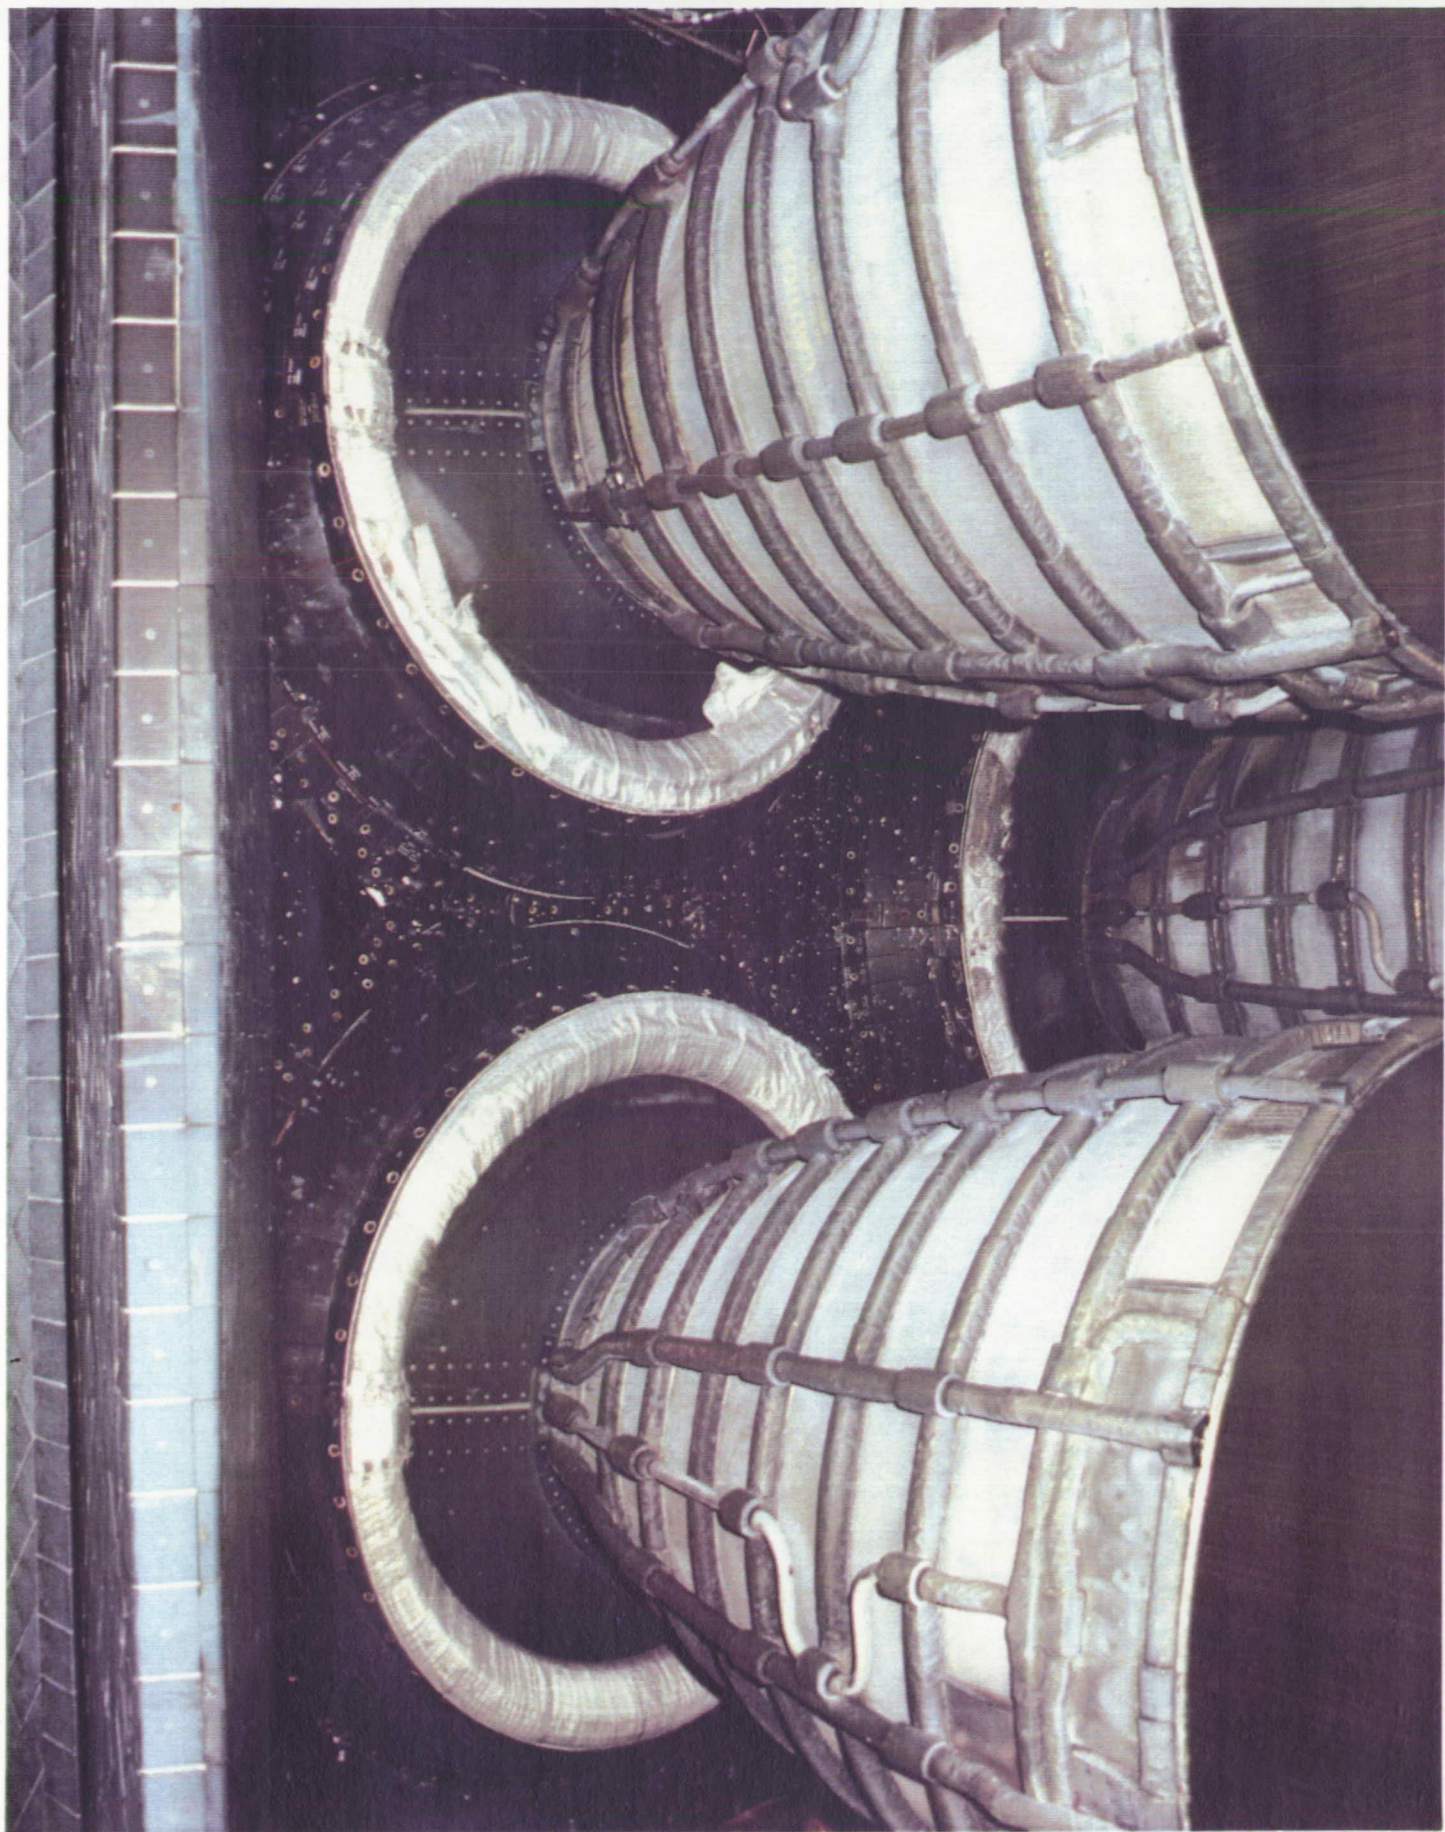
Overall view of SSME's. Damage to the base heat shield tiles was average with approximately 150 sites. All three SSME closeout beta blankets were frayed in localized areas.

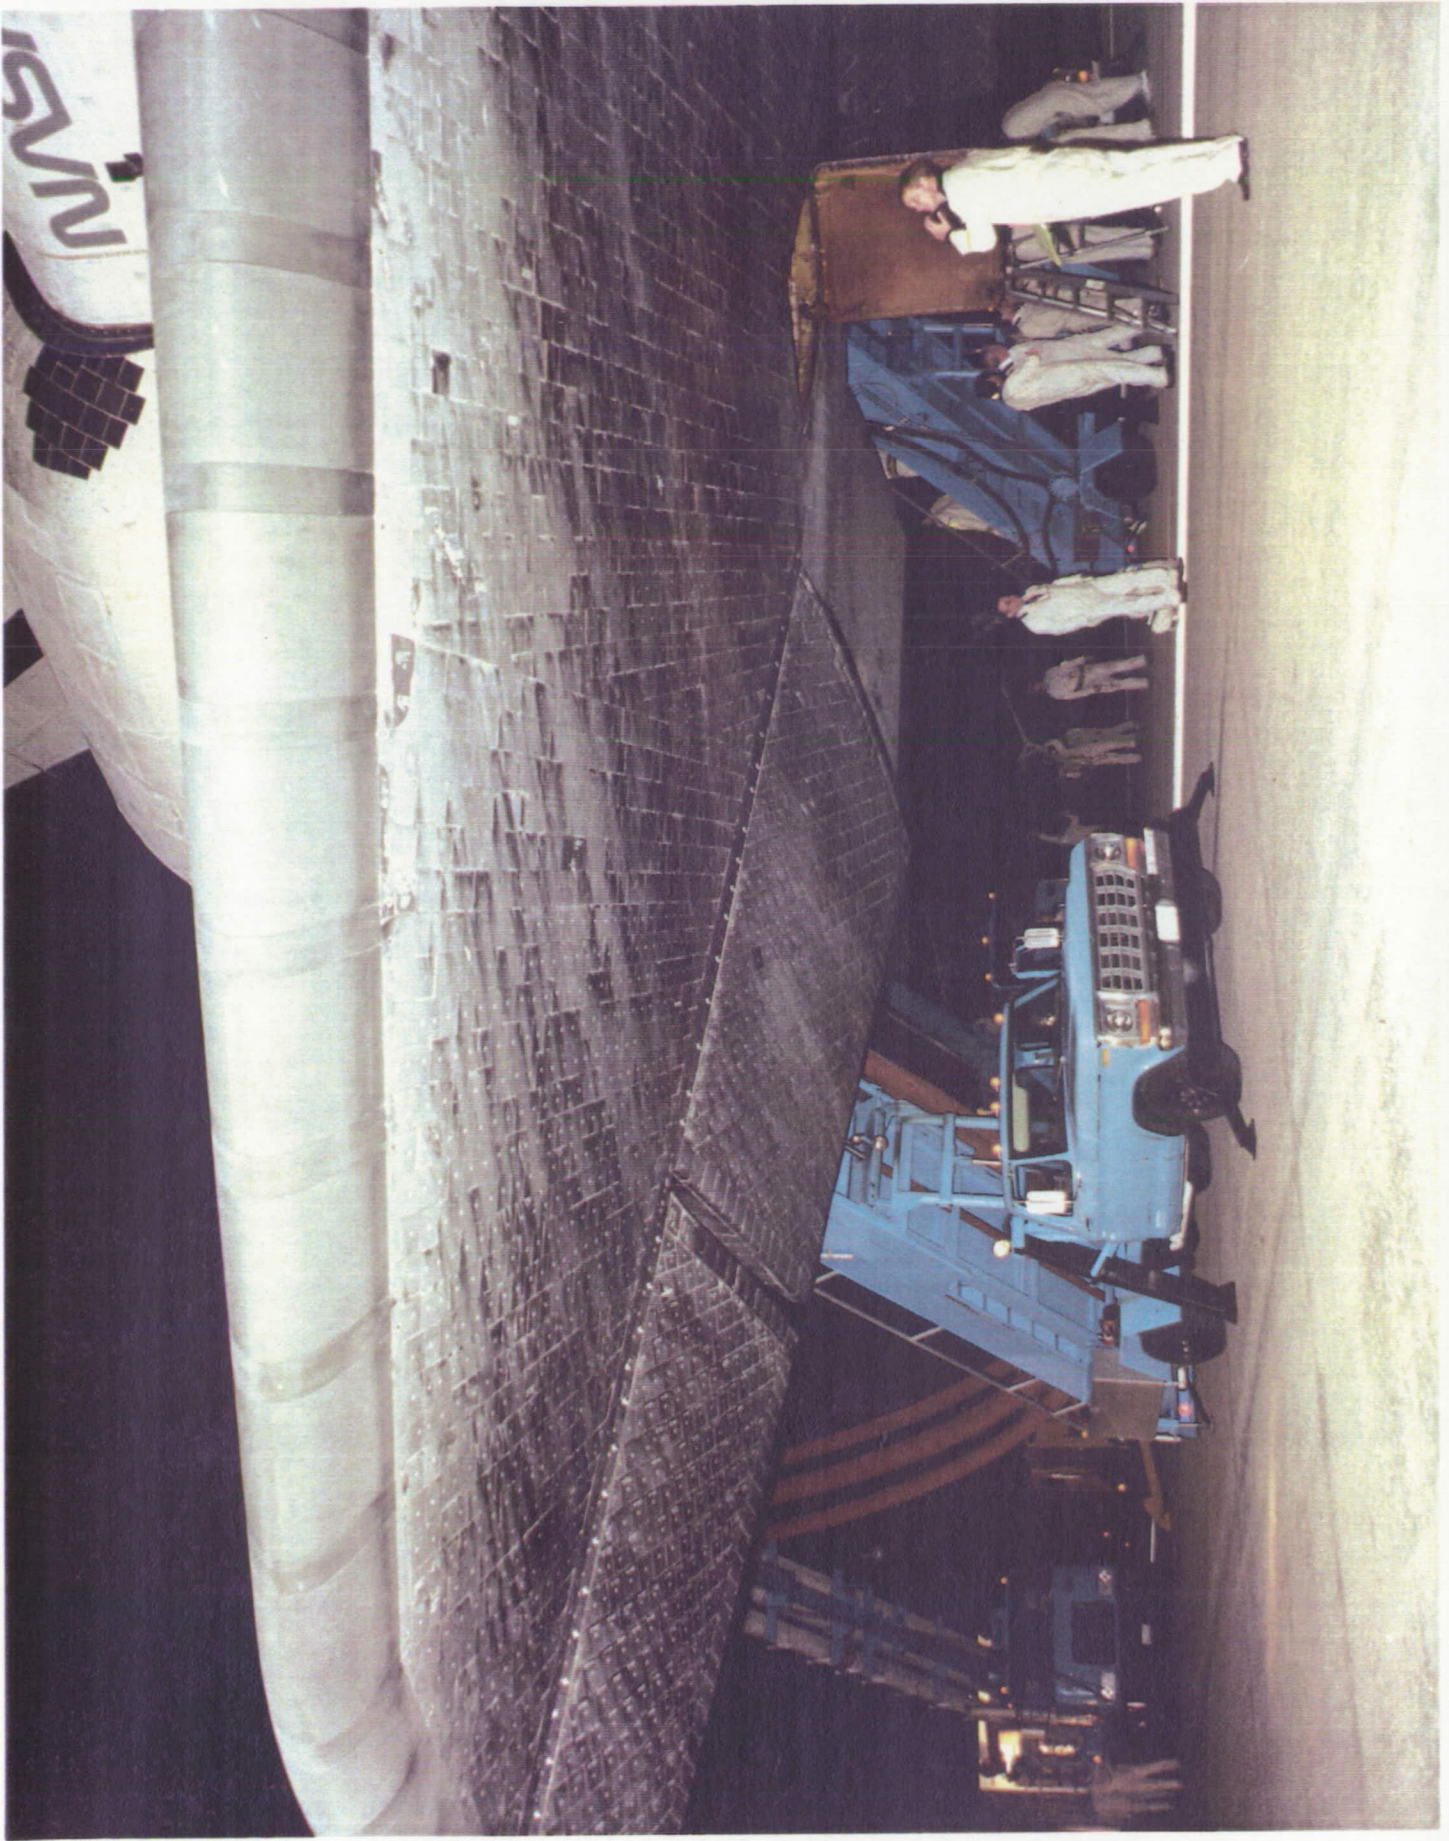
Lower surface tiles sustained a total of 70 hits with 7 of those damage sites measuring greater than or equal to 1 inch.
140

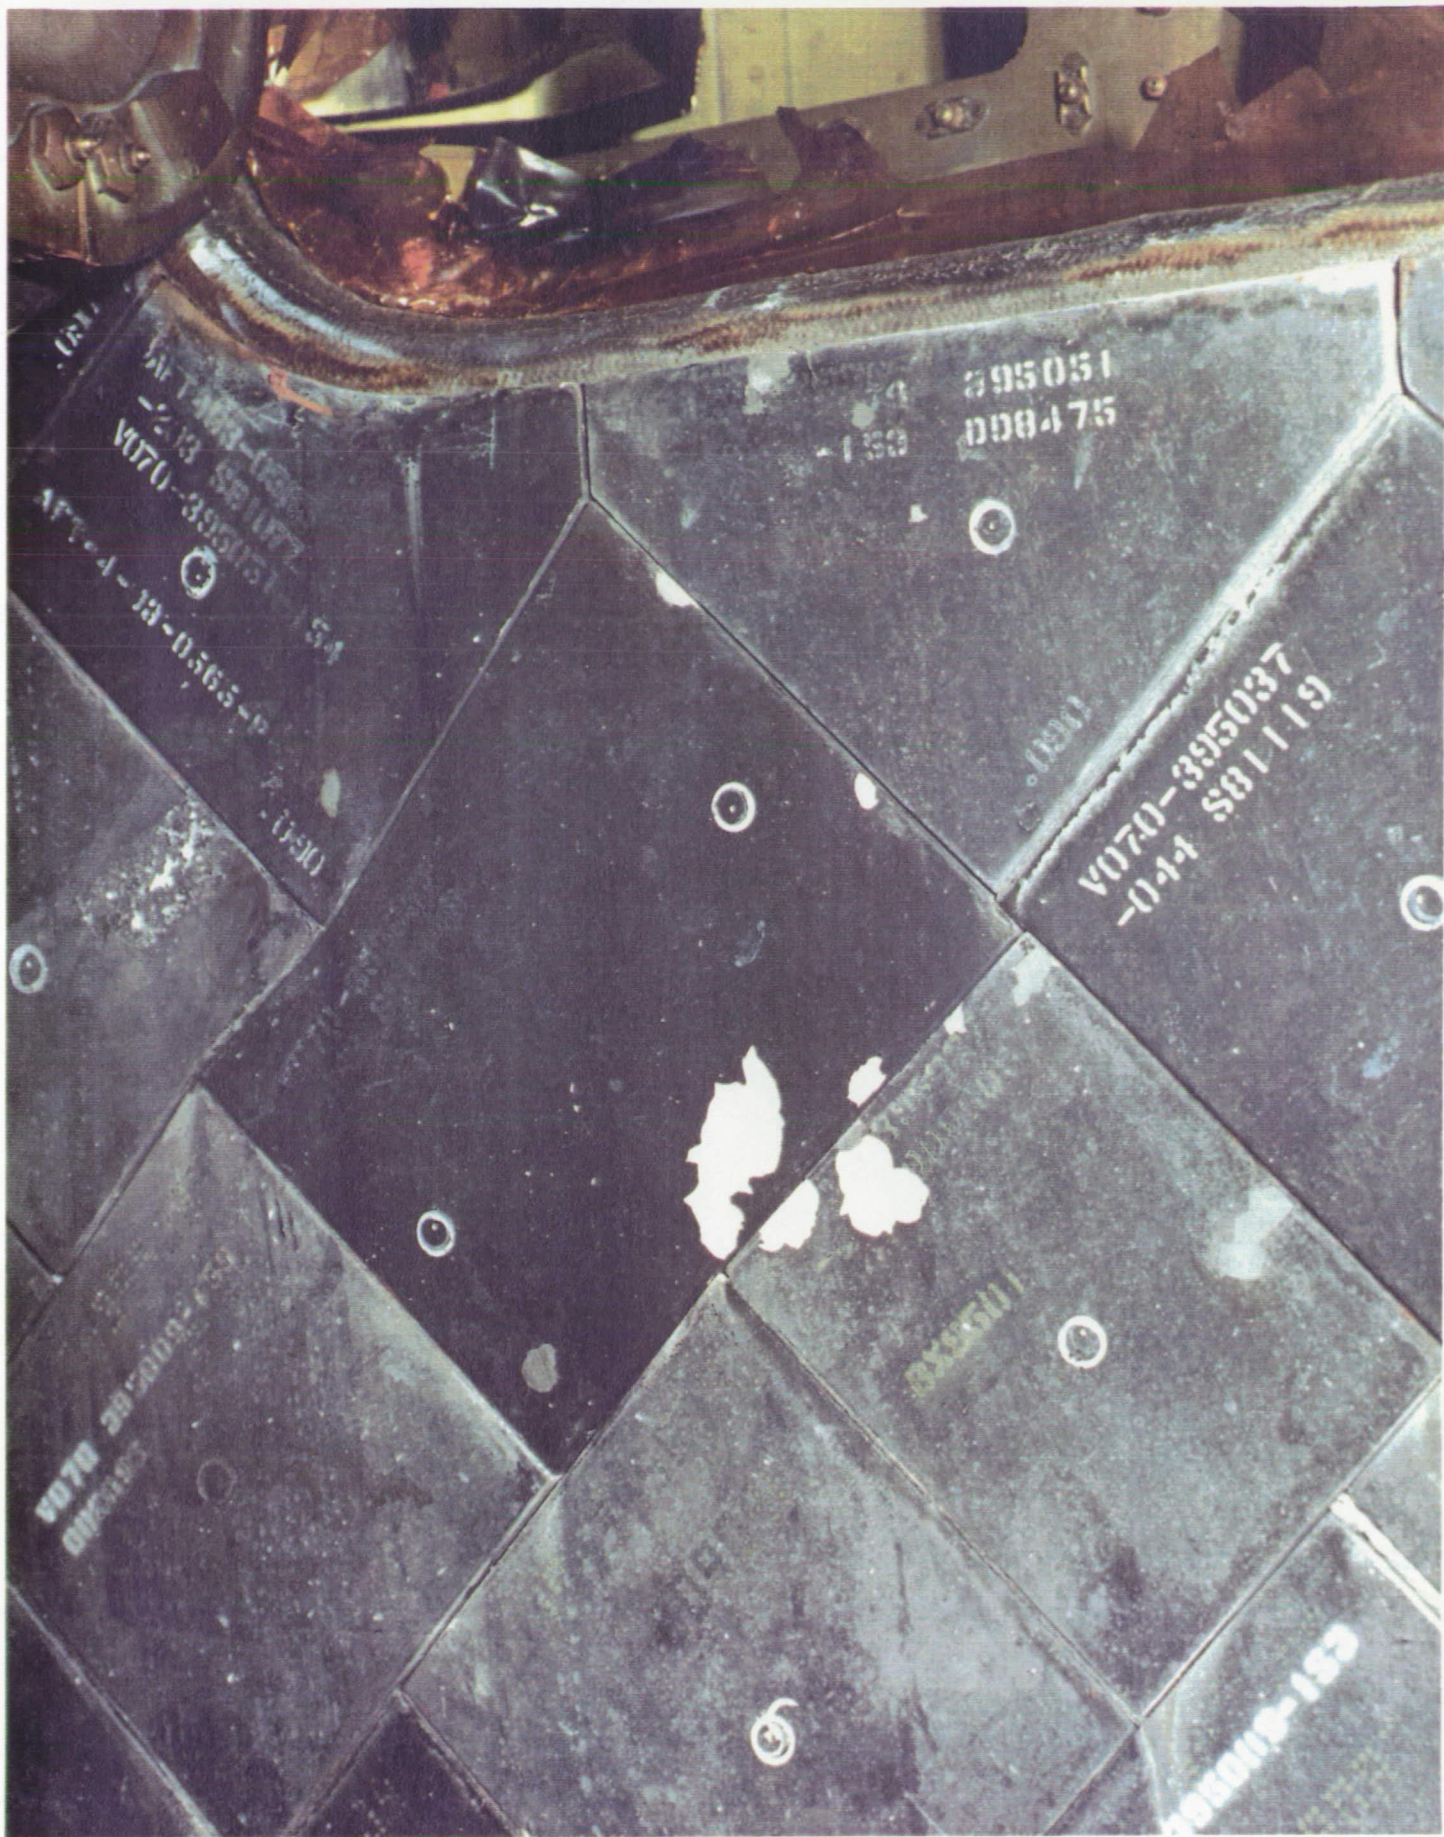
Typical debris impact damage to lower surface tiles near the
ET/ORB LH2 umbilical

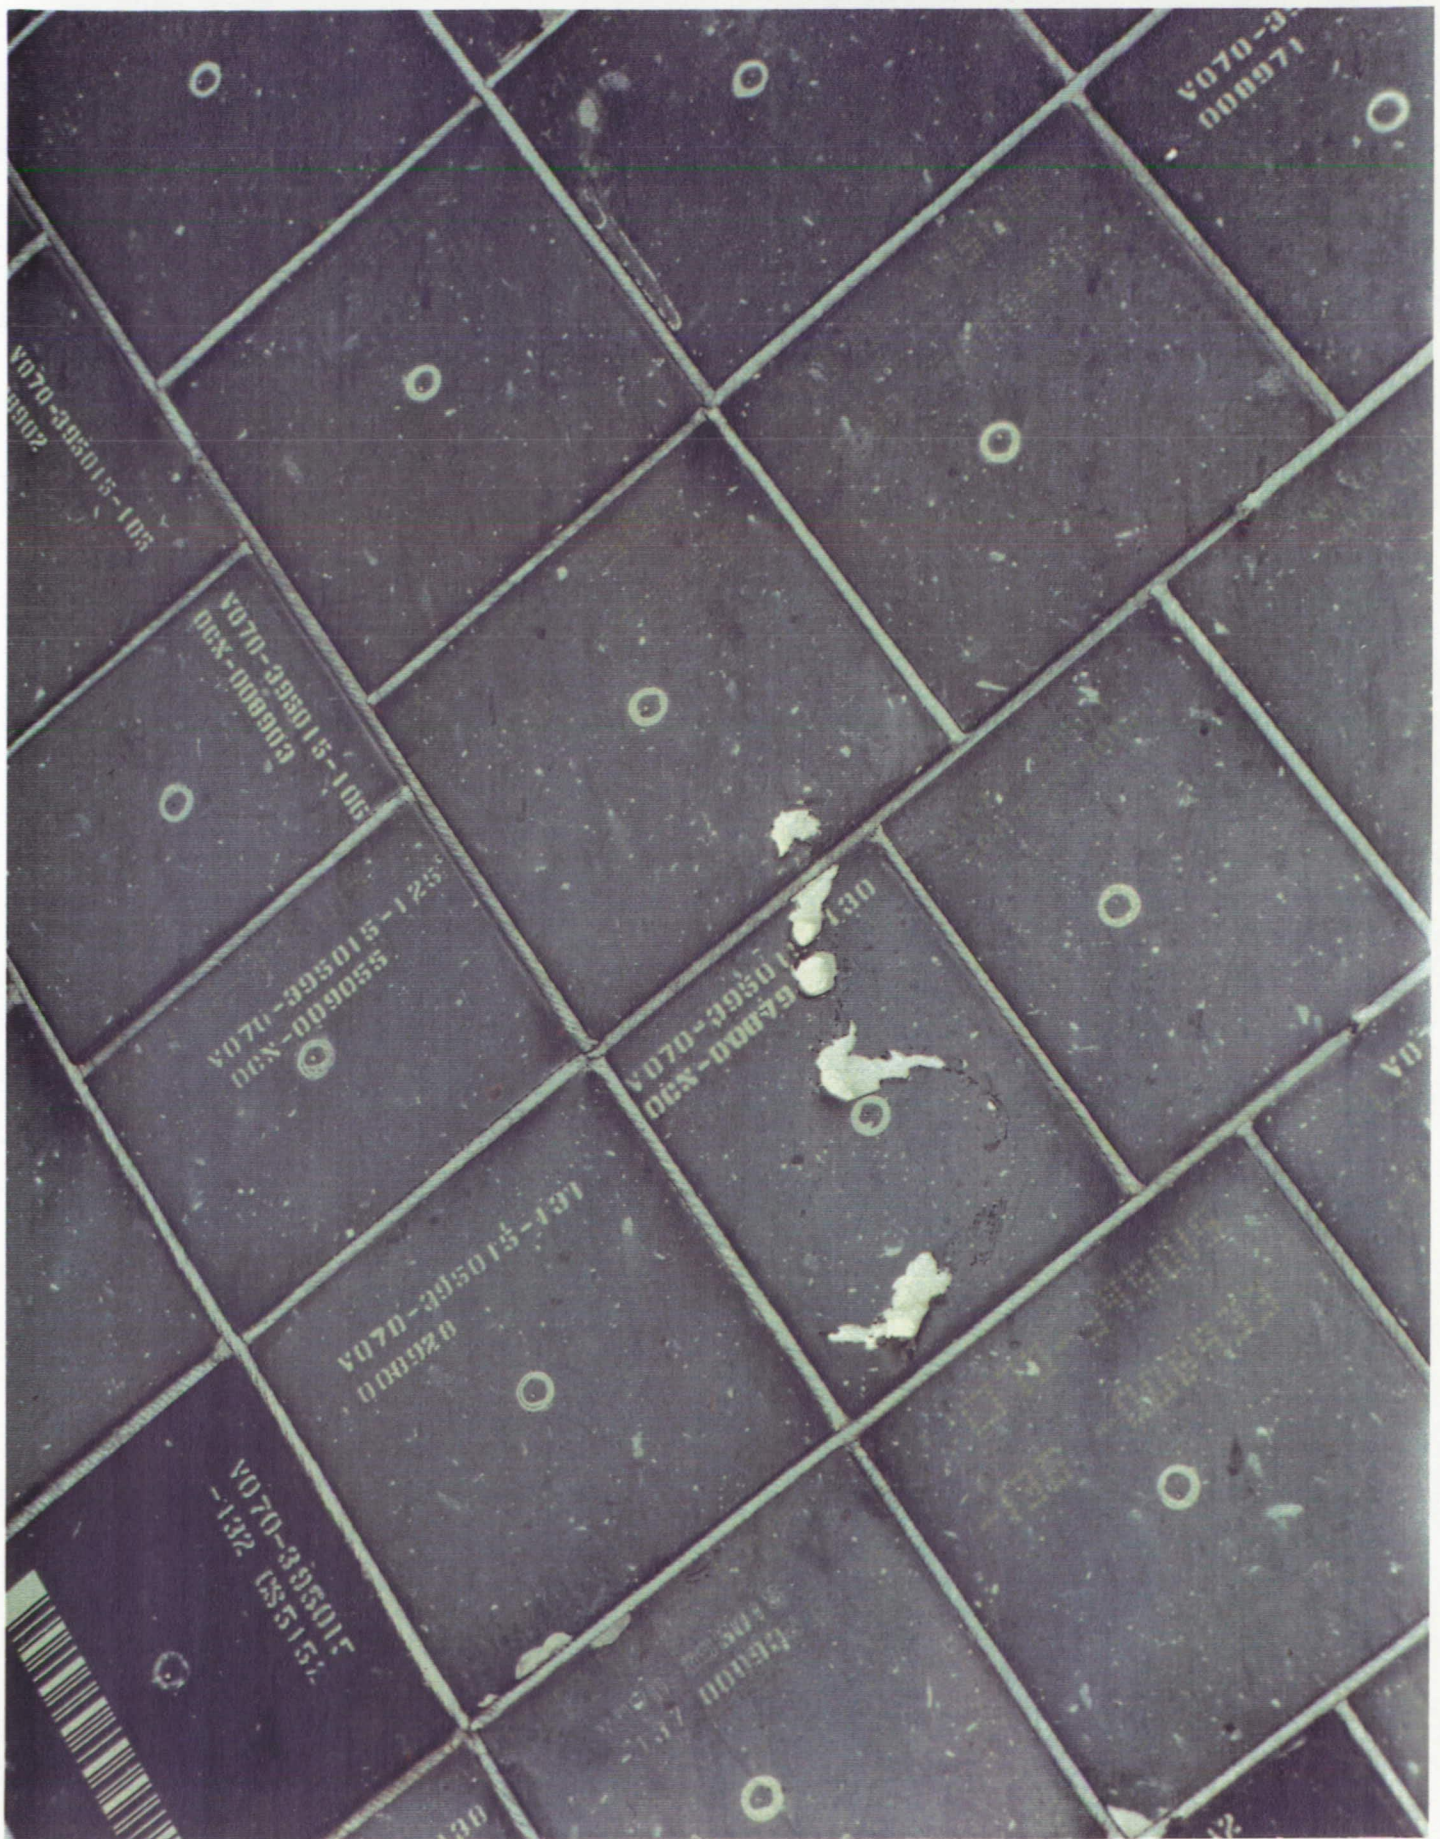
A total of 18 hits occurred on the body flap lower surface.
Some of the damage sites reached depths of 1/4 to 1 inch.

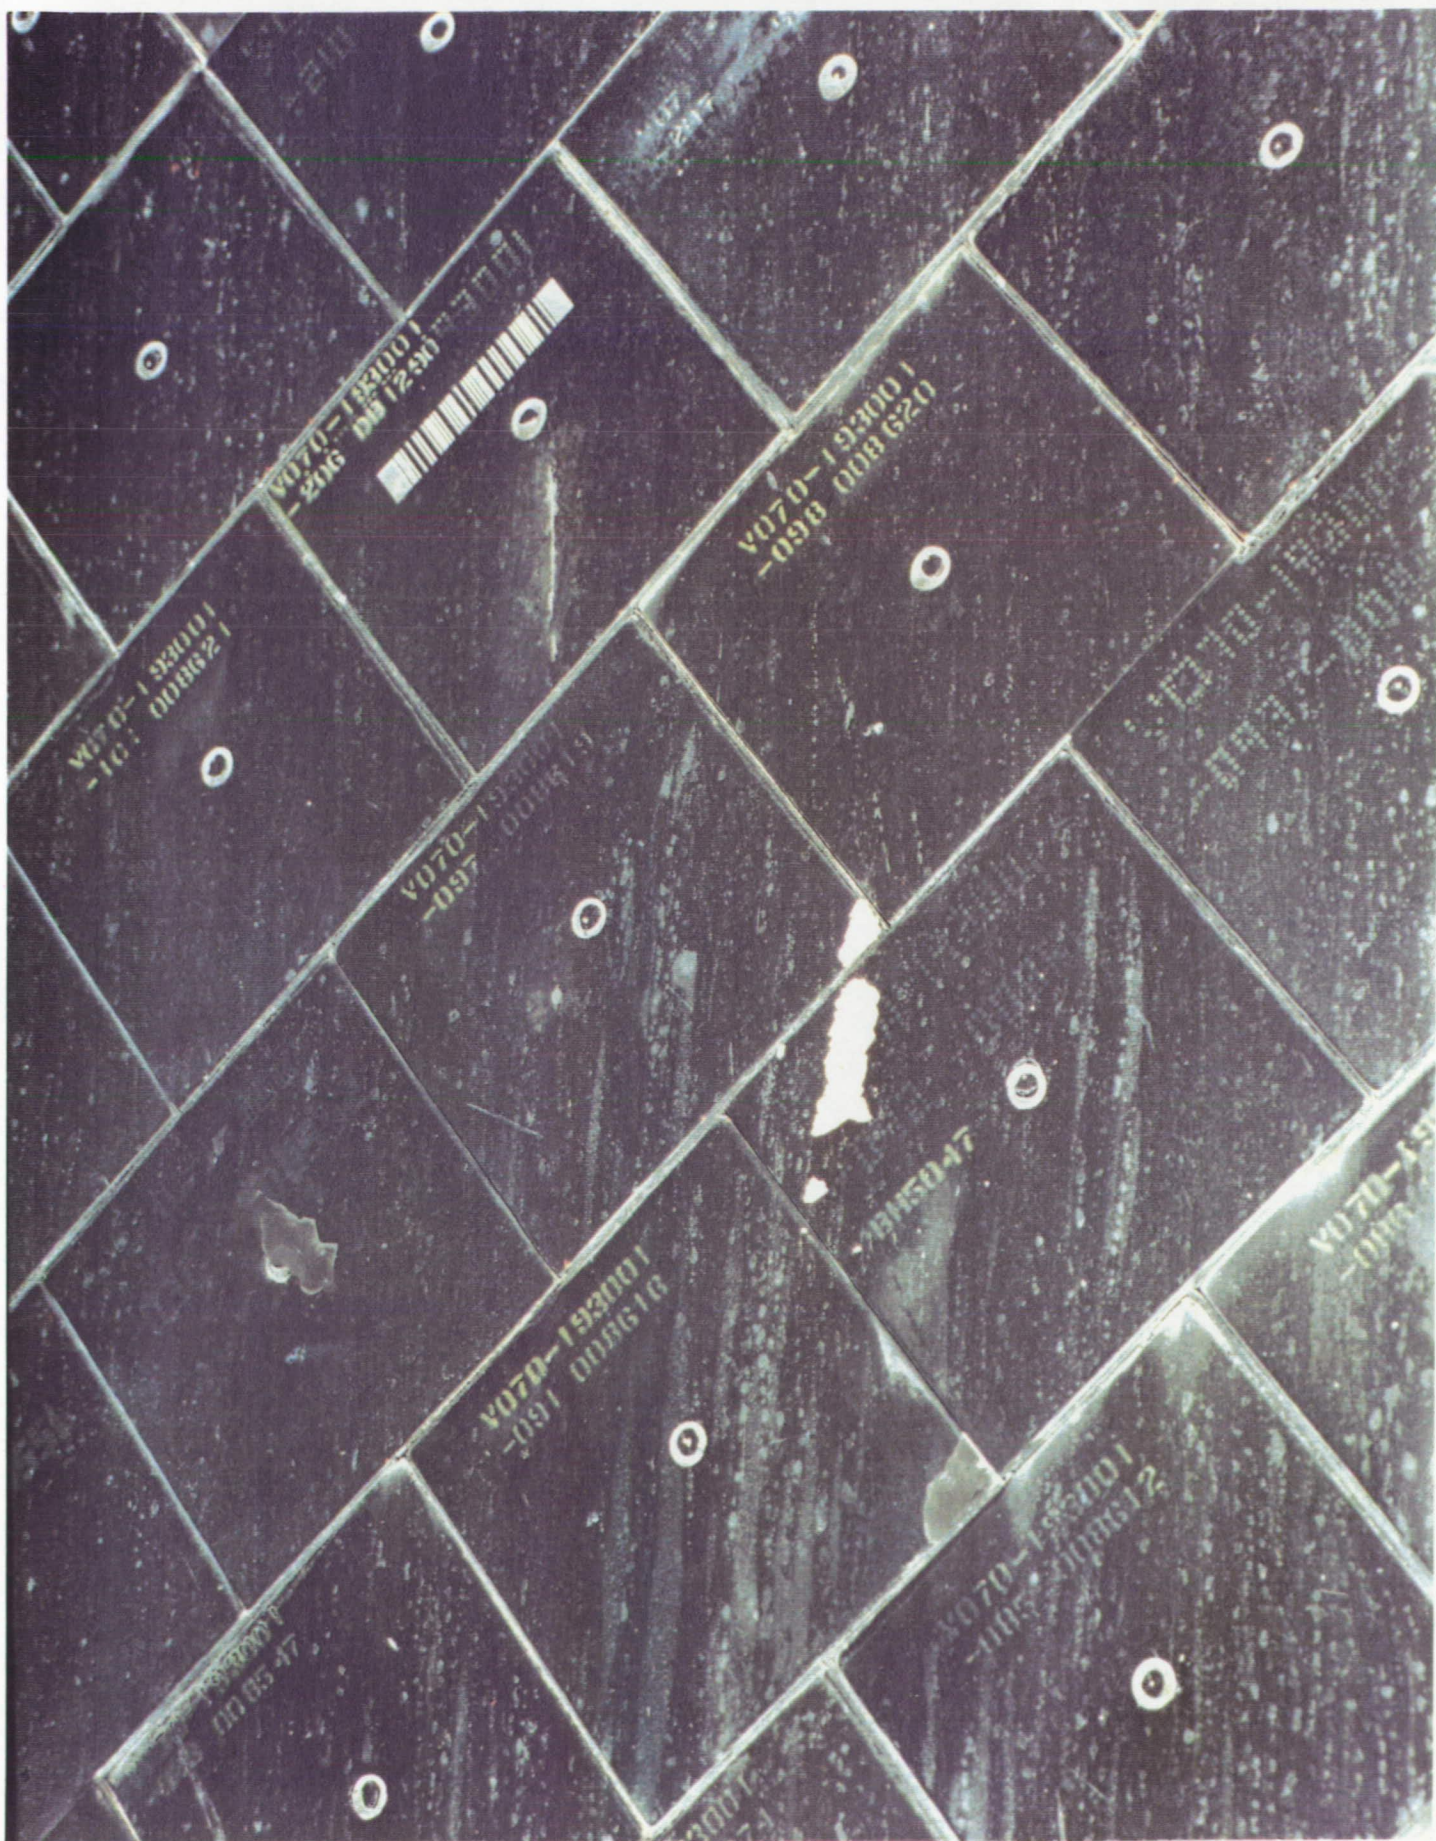
Typical debris impact damage to lower surface tiles
